A Deck Built to Fail

by James Eggert

Flashing, fastening, framing — you name it, it needed to be fixed

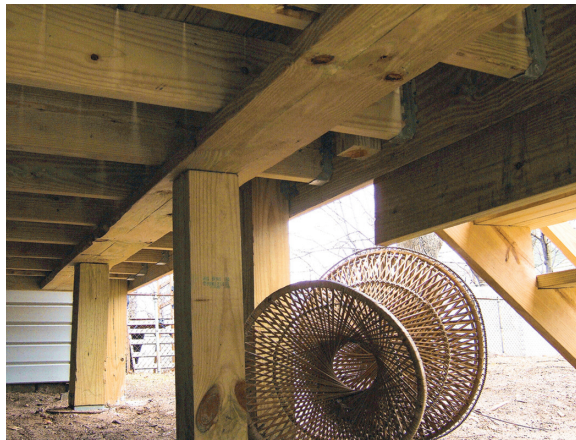
inside the rim. Posts rising from these piers — but not attached to them — supported a 2x8 nailed flat to the bottom of the joists to act as a beam (**Figure 1**).

But because a 2x8 on the flat isn't much of a beam, the inner piers weren't really supporting anything. That meant the outer three piers and the ledger were holding up three stories of deck loads. Some quick math gives us the load on the piers: 16 feet x 4 feet (half the deck's depth) x 50 pounds per square foot (psf) combined live and dead loads = 3,200 pounds per floor. That multiplied by three floors is a total load of 9,600 pounds, which divided by three piers is a load of 3,200 pounds per pier. A 12-inch-diameter pier provides bearing area of 113 square inches, and in average, 2,500-psf-bearing soils, one can carry 1,950 pounds — far short of 3,200 pounds. This deck was in trouble.

If you replaced the flat 2x8 “beam” at the interior run of piers with a real beam to handle half the load from the first floor, the outboard piers would still have to handle half of the load imposed by the second and third levels, or 6,400 pounds — a lot less than 9,600 pounds, but still more than the piers' capacity of 5,850 pounds (1,950 x three piers). Plus, I prefer to see a higher design live load — 60 psf or more — on a deck, because of party loading (for illustration, the live load requirement for restaurant decks is 100 psf), and by that standard these piers were even more inadequate.

Figure 1. Even with concrete footings below, a 2x8 on the flat does not qualify as a beam.

Fix: With the addition of a beam, the three inboard piers will be able to handle the first floor, but to support the second and third floors, piers must be added or the existing piers replaced with larger ones; post anchors must also be added (IBC Section 1805).

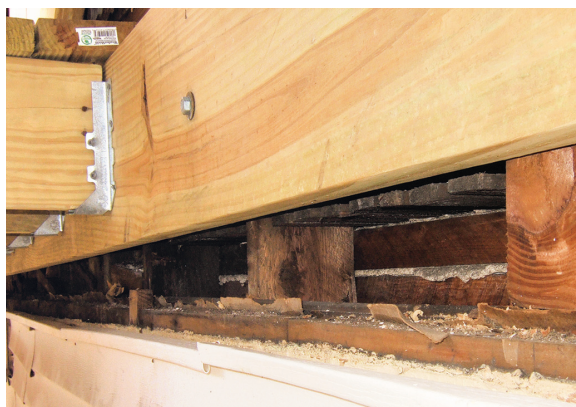
Figure 2. Required flashing and sheathing behind the deck ledger are missing, and the bolting schedule appears to be inadequate.

the house wall: There were no bolts, flashing, or sheathing, and I could look into the wall cavity and see the lath and plaster of the inside wall (**Figure 2**). (The contractor told me, “The siding repair is the owner's responsibility.” It doesn't matter to me who does it — it has to be done.)

Fix: Remove each ledger, add sheathing and flashing, then reinstall the ledgers with proper bolting.

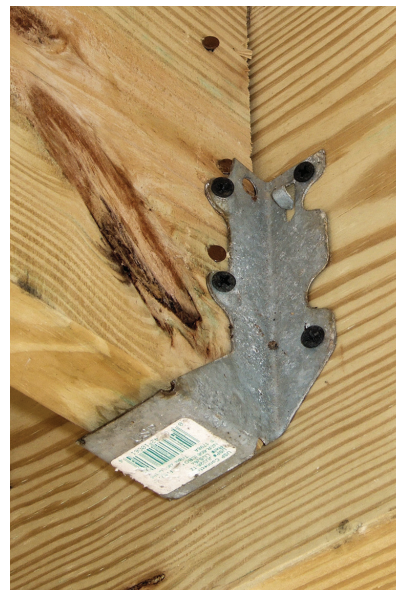
Inadequate joist attachment. Many of the joist hangers that attached the deck's 2x8 joists to the 2x10 rim joists were the wrong size. The single 2x10 rim joists actually do calculate out to be adequate support, but I couldn't find one nail in any of the joist hangers (**Figure 3**). The contractor had instead used drywall screws, which lack any meaningful shear strength and aren't resistant to corrosion. Another

Figure 3. Drywall screws lack both the shear strength and the corrosion resistance to be used as structural deck fasteners.

Fix: Add blocking where the hangers are “attached” to air; remove improper screws; and install 10d nails or structural screws, available from Simpson or USP, in every hole (IBC S2304).

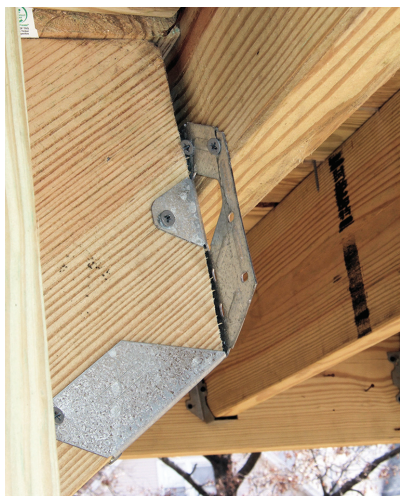
Figure 4. Every hole of a piece of framing hardware must be filled with the proper nail or structural screw.

problem was that many of the holes in the joist hangers were unfilled; some hangers — like those on the stringers, holding up the stair run — were installed with only one or two screws (**Figure 4**).

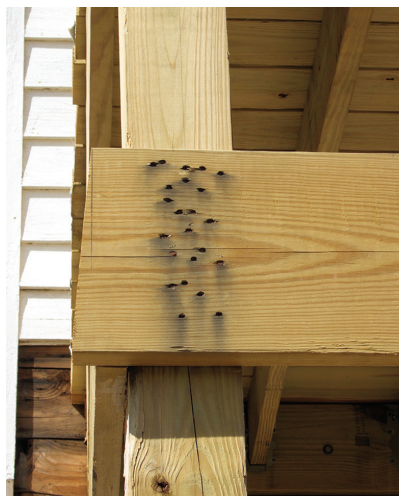
Figure 5. Non-corrosion-resistant nails are inadequate for this connection, no matter how many are used.

Nail troubles. While the joist hangers lacked nails, the rim board corners, the ends of horizontal railings, and the single headers were nailed with too many nails (**Figure 5**). For example, I counted 28 nails at one rim-to-corner-post connection. Though the codes specify only a minimum number of nails for certain connections, common sense should tell a carpenter that using too many nails will crack the lumber and reduce its

structural capacity. Anyway, a nailed connection wasn’t adequate in these places, and even if it were, none of the nails used were galvanized or stainless steel; I could see the corrosion stains on the wood.

Fix: Add corrosion-resistant through-bolts (IBC S2304).

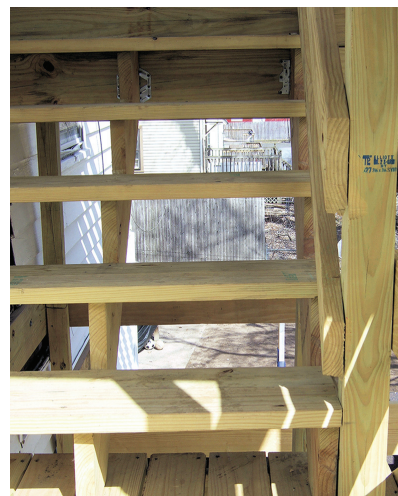
Figure 6. Stair rises cannot vary more than $\frac{3}{8}$ inch throughout a flight.

All five runs of stairs had rise and tread discrepancies and undersized landings, and two of the runs had headroom issues. The rises, whose heights are supposed to be within $\frac{3}{8}$ inch of each other in each flight, were all over the place (**Figure 6**). On one flight, the rises ranged from 6 inches to as much as 7 $\frac{1}{2}$ inches. The risers were open, with more than a 4-inch space, and some of the treads were only 8 inches wide where R2 occupancies require 11 inches of width.

Fix: Rebuild stairs and landings to code, adjust header placement to create adequate headroom, close the open risers, add handrails, and add safety glazing to the windows (IBC Chapter 10 and S2406).

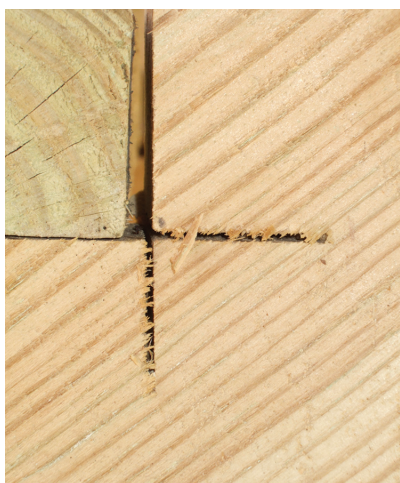
The stairs had other code violations. There were no graspable handrails and the stringers were overcut (**Figure 7**). Plus, window glazing was located only inches from the ends of the stair treads (**Figure 8**); because of the lack of safety glazing, the window could be broken

Figure 7. Overcuts weaken stringers and reduce the uncut portion to less than the code-required 5 inches.

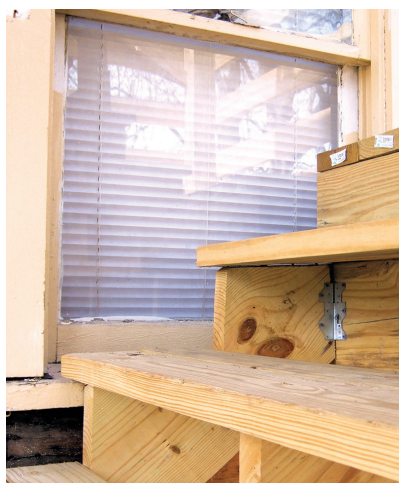
Figure 8. Safety glazing must be used near stairs.

by a snow shovel, or someone could fall down the inconsistent stairs and be cut.

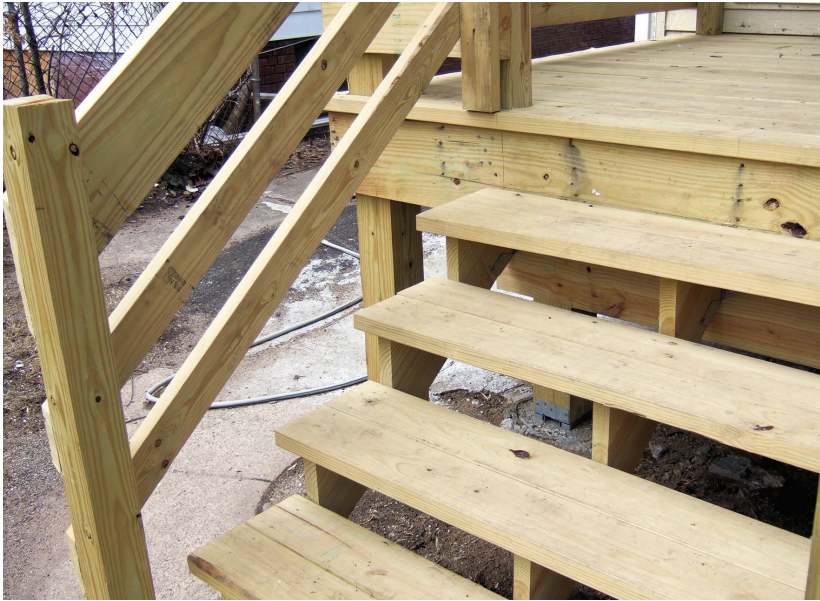
Figure 9. On notched stairs, the space between the bottom guard and the rear of the treads must be no larger than 6 inches.

Guards. The guards were nailed to the corner posts with nongalvanized fasteners. Adding some galvanized screws would help, but there were more problems. The horizontal rails were spaced more than 4 inches apart, and the space between the stair guards and the back of the stair treads exceeded the 6 inches allowed by code (**Figure 9**). The contractor did get the height of the guard right: 42 inches because of the R2 occupancy.

Fix: Correct the guard spacing and replace all fasteners with noncorrosive ones (IBC S1012.)

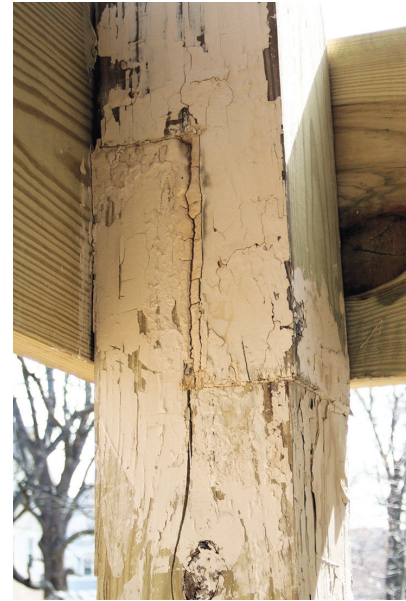
Figure 10. Lapped joints in structural posts must be through-bolted.

Corner posts. The corner posts were substantial — 6x6s — but the half-lap joints between the members looked like they were cut with a dull chain saw, and they were simply nailed together (**Figure 10**). To hide the visual prob-

lem and cover the choppy post-to-post laps, the contractor had installed regular wood putty at each corner.

Fix: Grind the putty away and add through-bolts (IBC Chapter 23).
